Capricorn Contract & Supplies Ltd

Project Restoration 15 Offices London

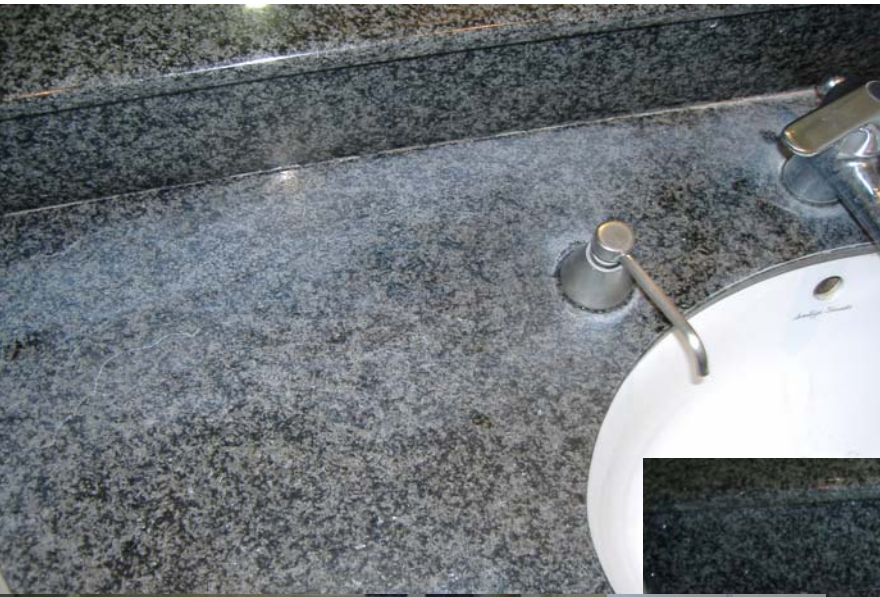
Granite vanity units with heavy limescale deposits that had eaten into the surface this had caused a very unsightly mark across the granite and in some places damaged the stone

The granite was badly pitted by the limescale and therefore had to be diamond cut and then polished to restore the surface. The granite was then sealed with Fila Hydrorep impregnating seal and given a final polish.
