# **Capricorn Contract & Supplies Ltd**

**Cleaning, Protecting & Care Treatment of Ceramic Tiles, Slabs  
Terracotta, Terrazzo, Natural & Artificial Stone, Concrete Slabs**

## **Project Restoration 4**

## **London**

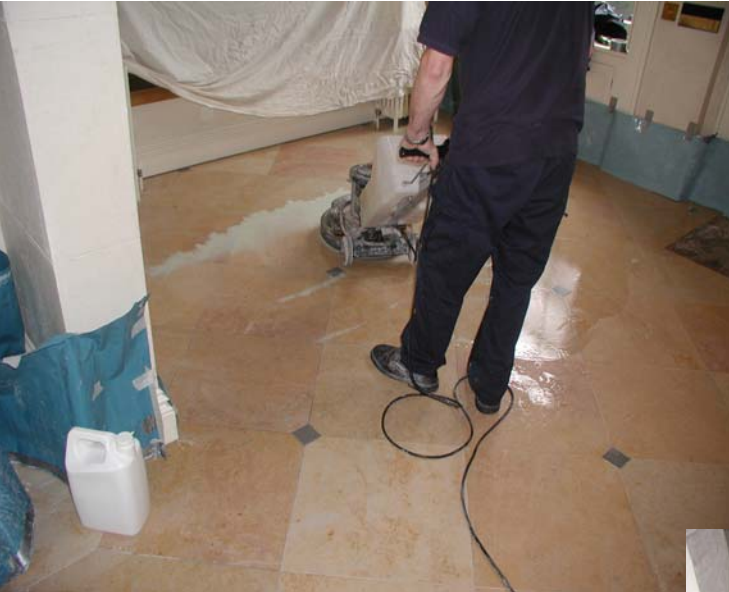
*Marble floor damaged with scratch marks and incorrect seal applied causing the floor to go dull with swirl marks.*

*The floor was chemically Stripped to remove the seal And then acid etched to Remove the scratches and Bring back the shine, the floor was then sealed. The photo above shows the final etching sequence.*
