Capricorn Contract & Supplies Ltd

**Cleaning, Protecting & Care Treatment of Ceramic Tiles, Slabs
Terracotta, Terrazzo, Natural & Artificial Stone, Concrete Slabs**

Project Restoration 5

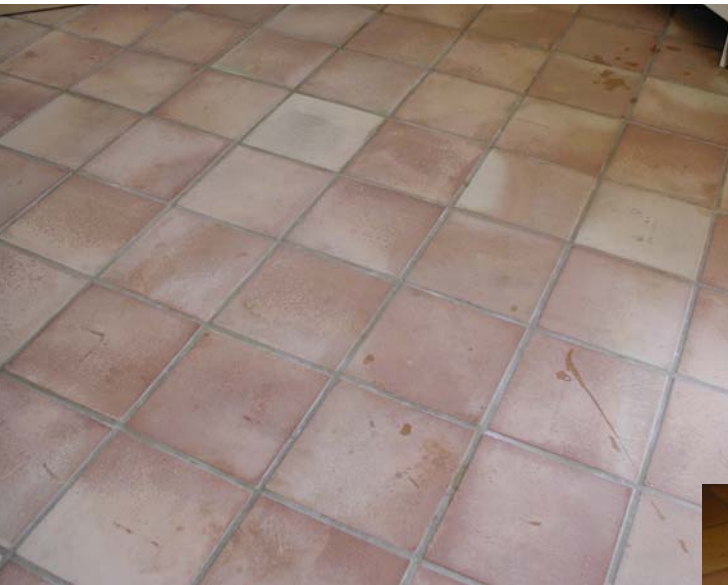
Machined Terracotta floor badly damaged by acidic cleaners used for cleaning the floor, the seal had been removed this allowed staining to penetrate the terracotta. The surface of the tile had also been damaged by the cleaners used.

The Terracotta was first skimmed to remove the damaged surface then the surface was bonded to prevent further damage to the tile.

Hot wax treatment was then applied and a final treatment before buffing the floor to the required finish.
