Capricorn Contract & Supplies Ltd

Project Restoration

Watford

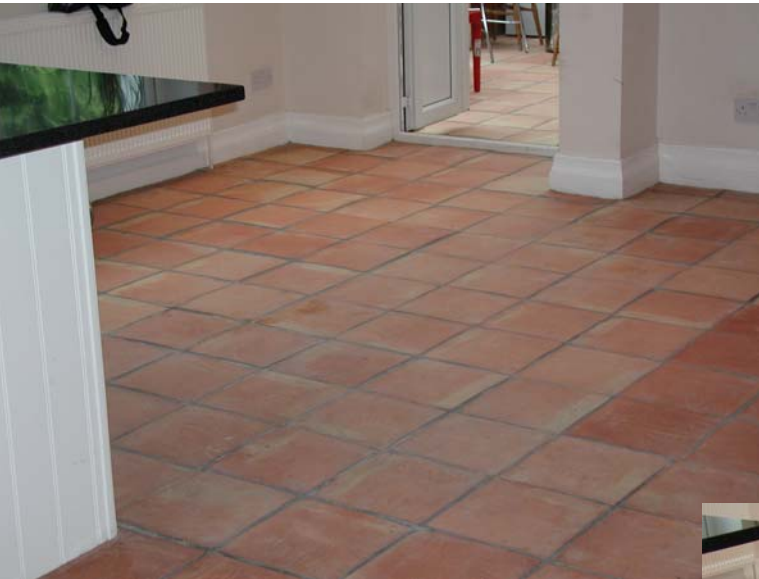
Hand made Terracotta floor with excess grout covering the surface and a wax seal put on on top. the floor looked very dirty and was not properly sealed thus allowing stains to penetrate.

The floor was first cleaned and stripped of all finishes, it was then treated to remove the grout residue, once cleaned the floor was dried, waterproofed and then a base wax applied, a final finish was put on and then buffed to required finish.
